Subject: Department of Natural Resources Washington Geological Survey,
School Seismic Safety Assessment Project, Contract No. AE 410 -
Seismic Evaluation for **Index School District**

1. Index Elementary School, Enclosed Covered Play
2. Index Elementary School, Main Building

Index, Index Elementary School, Enclosed Covered Play

Index, Index Elementary School, Main Building

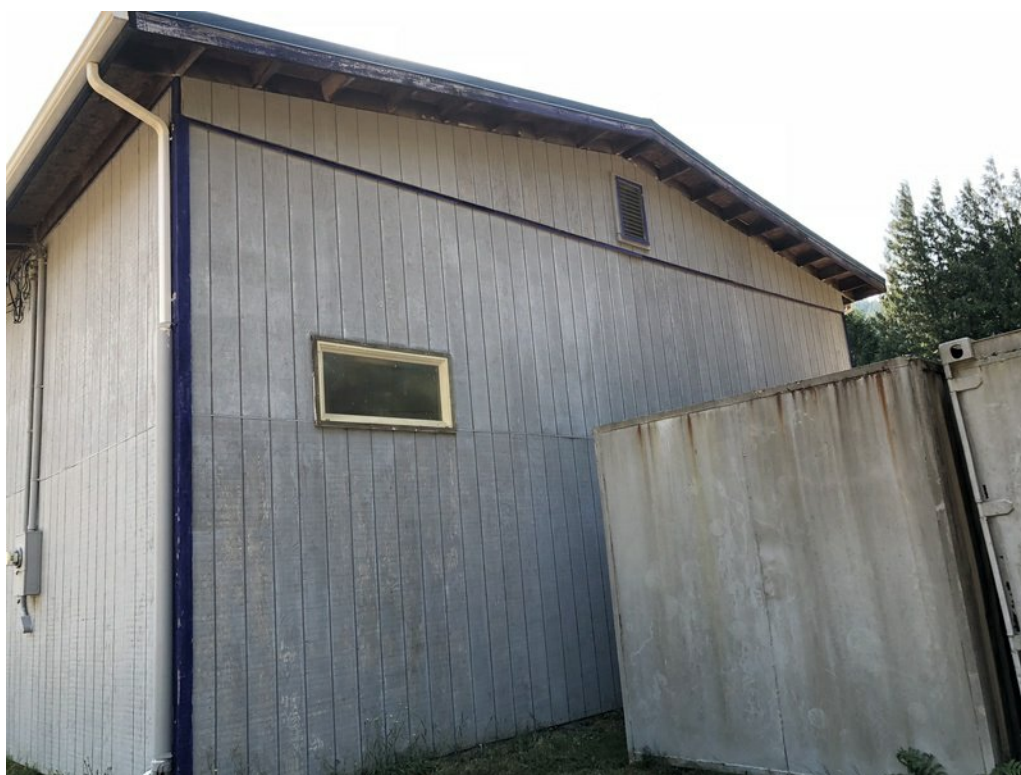
Figure 1-1. West Exterior of Enclosed Covered Play Building

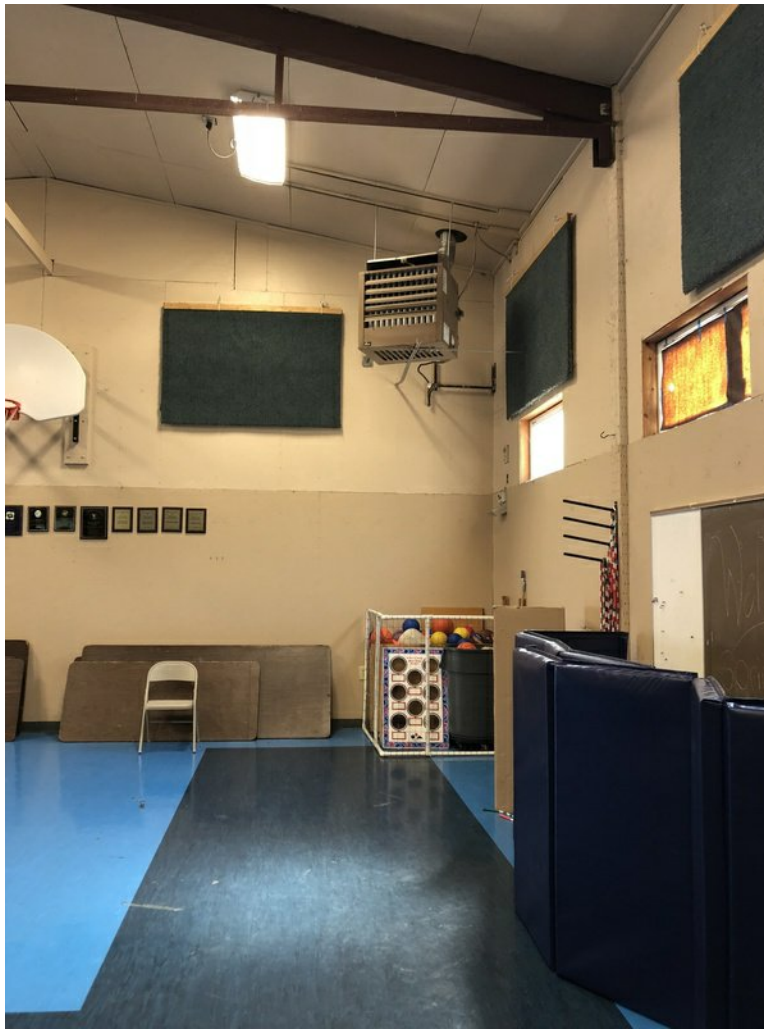
Deficiency	Description
CF-3 Fall-Prone Contents. HR-not required; LS-H; PR-H.	Elevated mechanical equipment at the southeast corner requires additional bracing and anchorage back to the wall to avoid becoming a falling hazard.
ME-1 Fall-Prone Equipment. HR-not required; LS-H; PR-H.	Elevated mechanical equipment at the southeast corner requires additional bracing and anchorage back to the wall to avoid becoming a falling hazard.

Figure 1-2. Suspended Mechanical Equipment on East Exterior Wall (looking east)

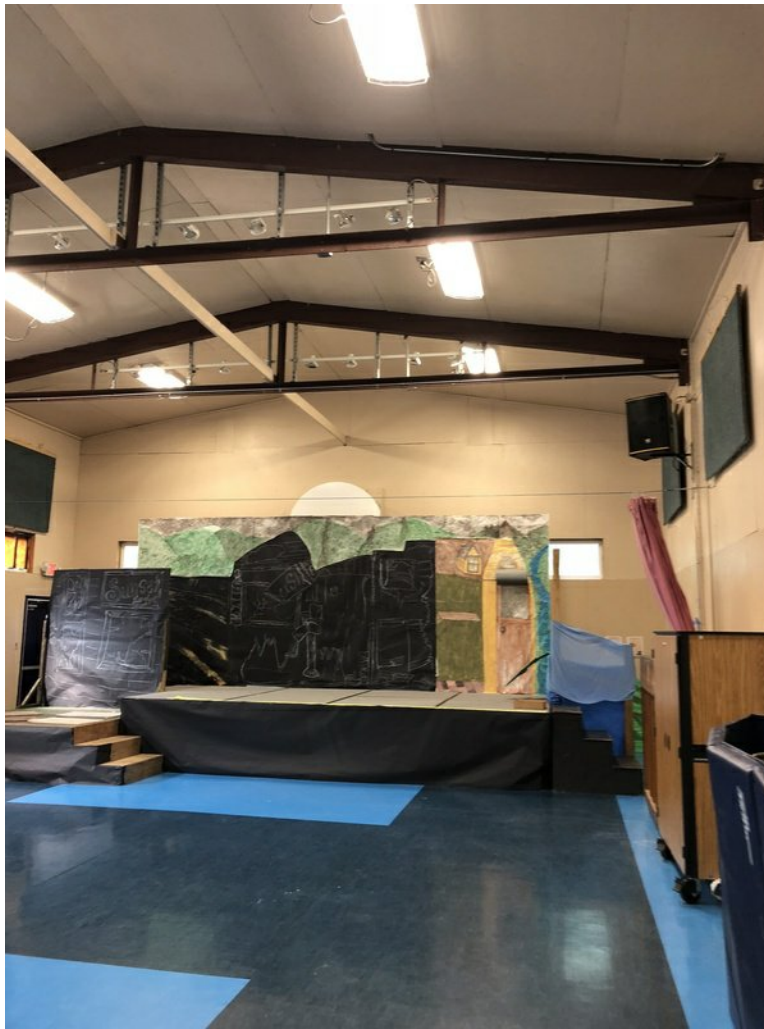
Figure 1-3. Steel Roof Trusses (looking West)

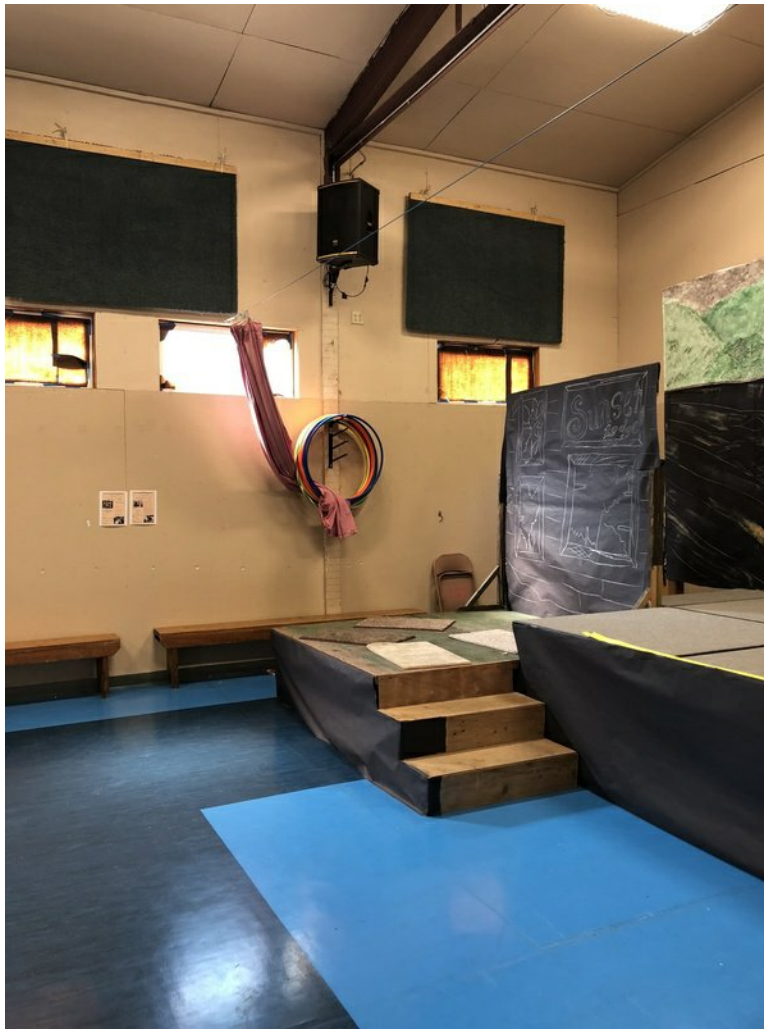
Figure 1-4. Window Openings in South Exterior Wall (looking South)

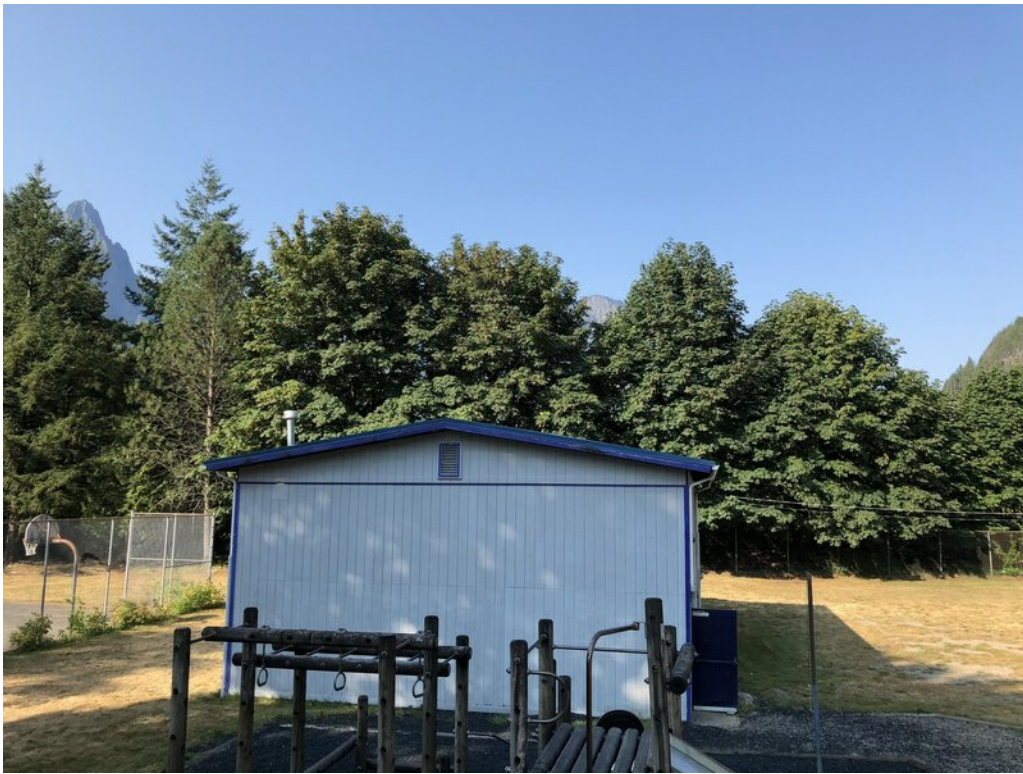
Figure 1-5. East Exterior Wall

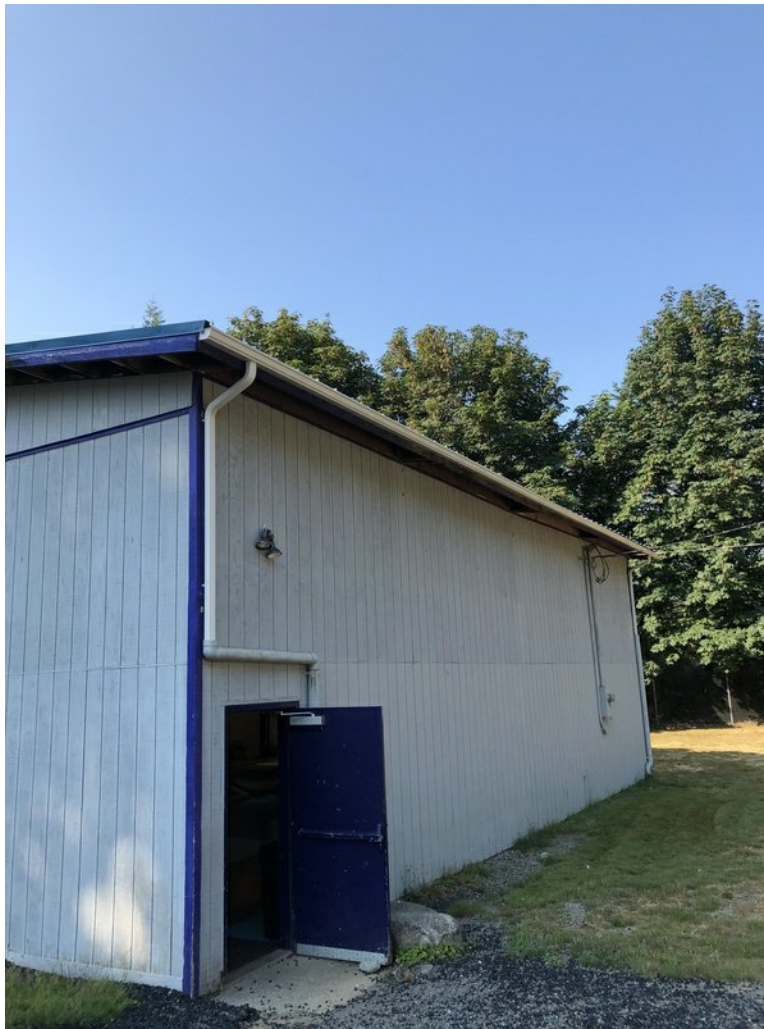
Figure 1-6. North Exterior Wall

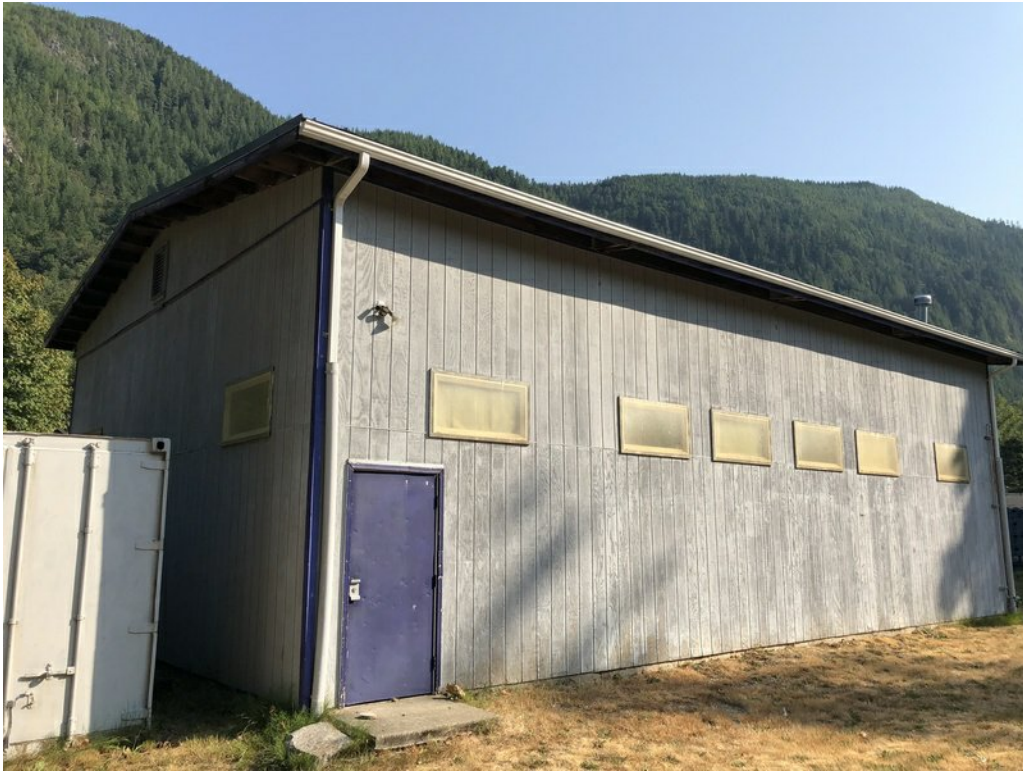
Figure 1-7. South Exterior Wall

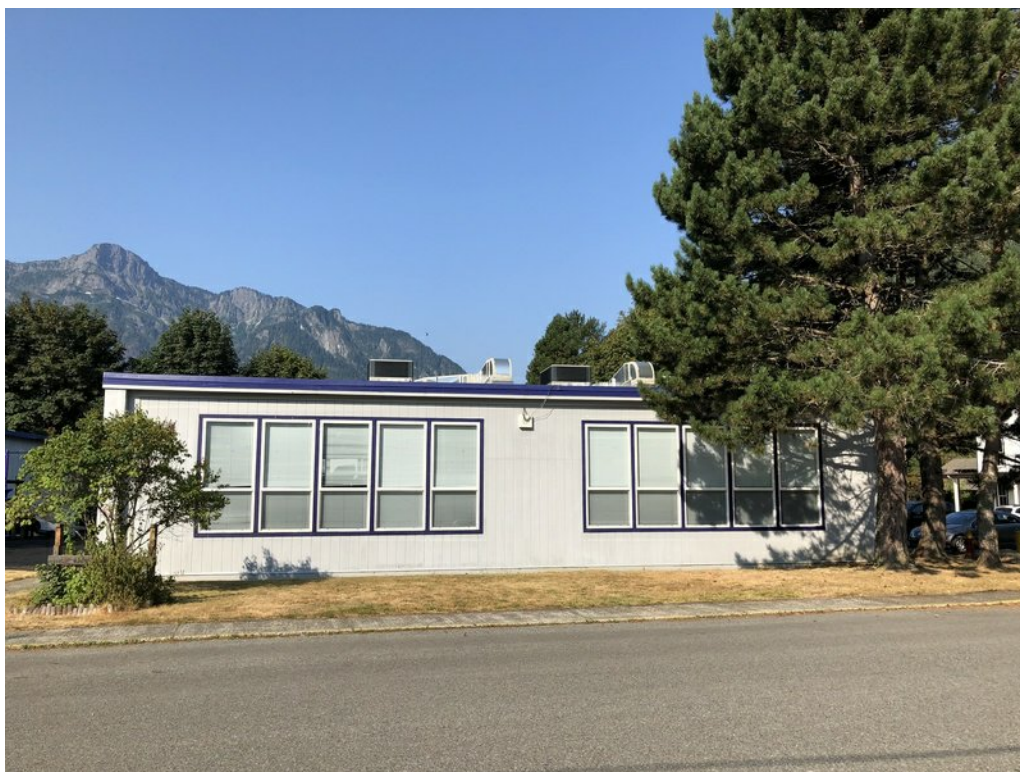
Figure 1-1. East Exterior Wood Shear Walls of the Classroom Area

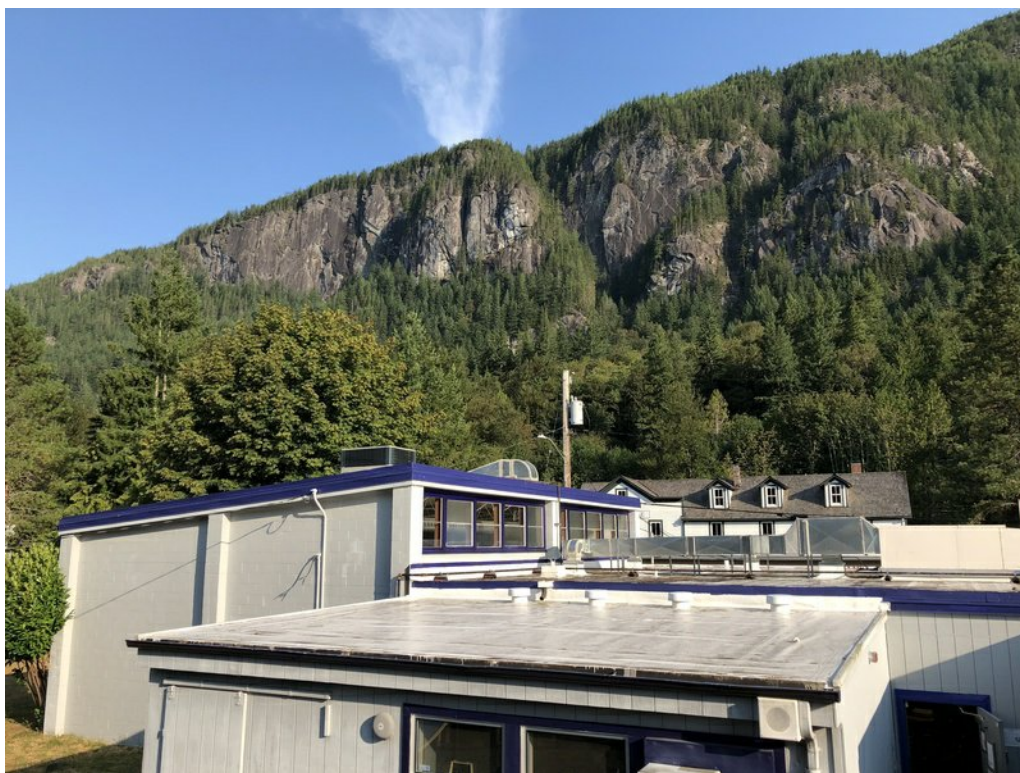
Figure 1-2. High Multipurpose Roof with High Band of Windows and Lower Admin Roof (Looking North)

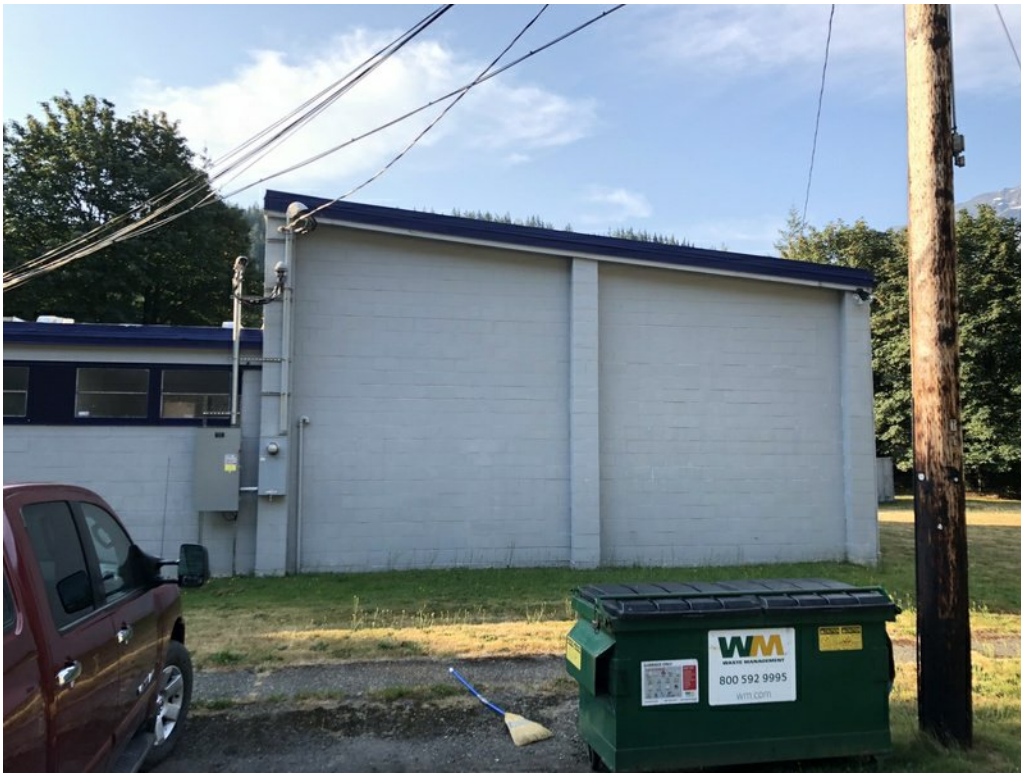
Figure 1-3. North CMU Wall of Multipurpose Area

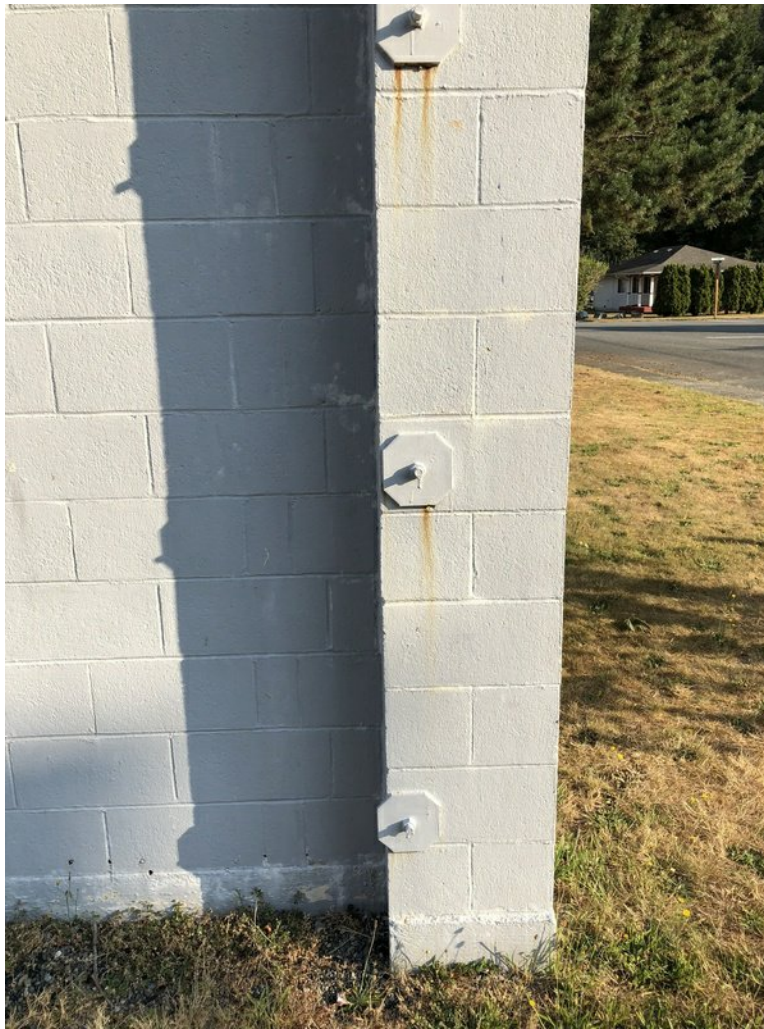
Figure 1-4. Rosette Anchors at SE and NE corner Pilasters of Classroom Area

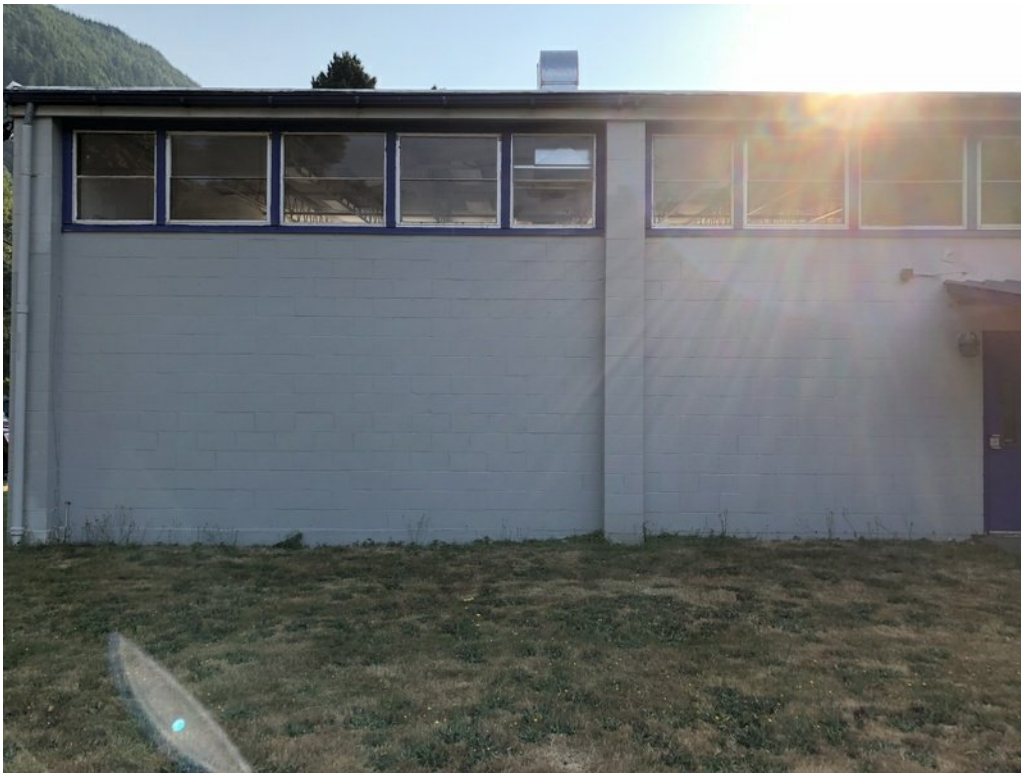
Figure 1-5. West Exterior Wall of the Multipurpose Area with High Band of Windows and Full-Ht Pilasters

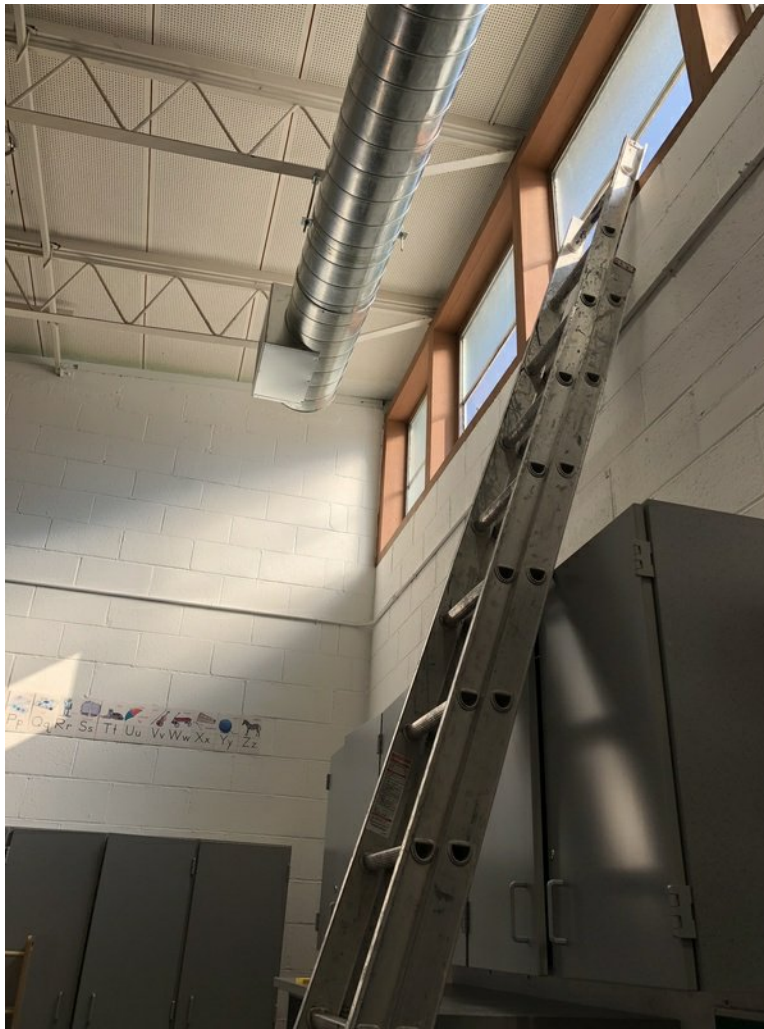
Figure 1-6. East Wall of Multipurpose Area with High Band of Windows, Wood King Posts, and Joist Bridging to North Exterior Wall

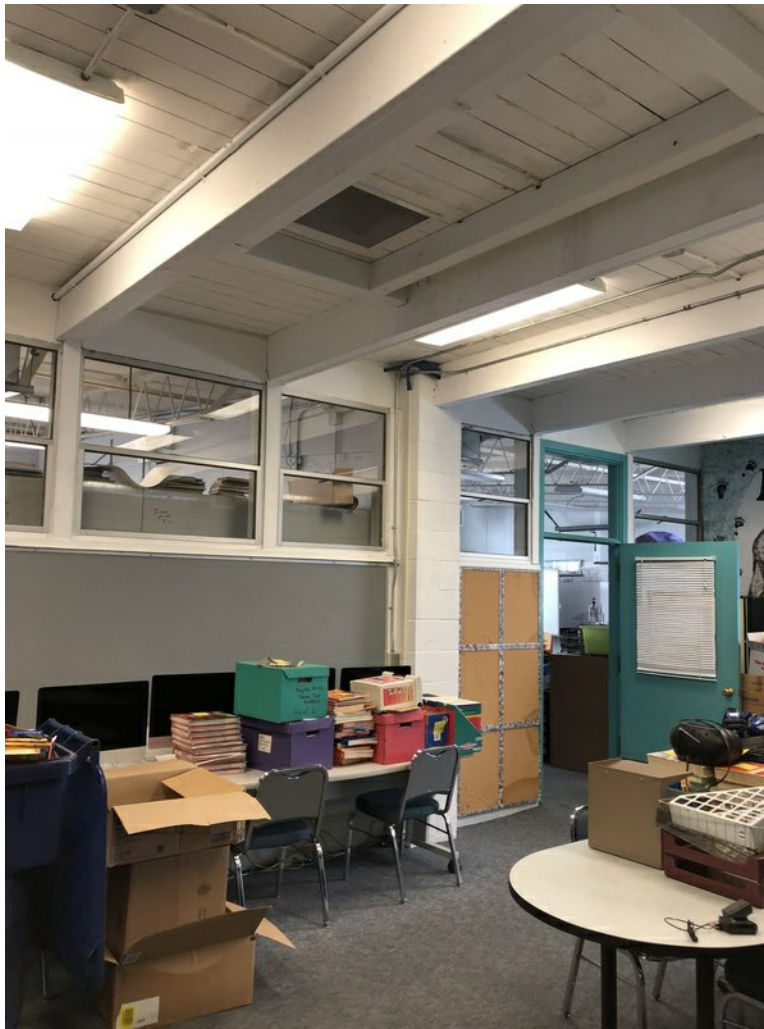
Figure 1-7. Wood Framed Roof Over the Admin/Shared Area (looking southeast)

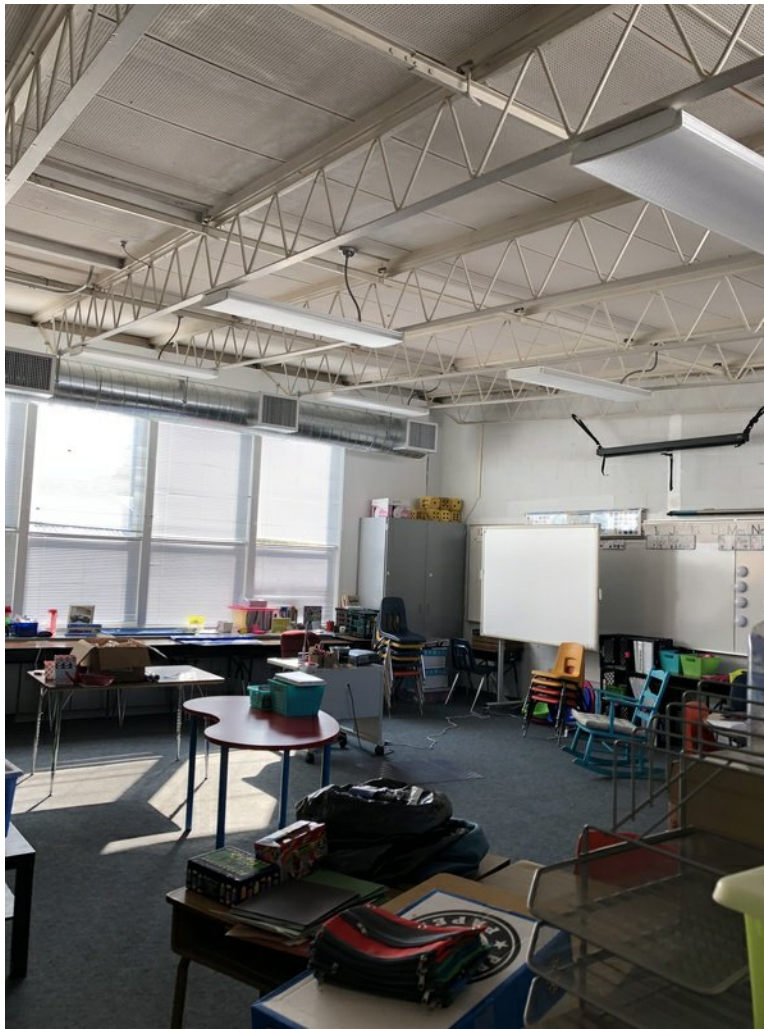
Figure 1-8. Steel Roof Joists and Gypsum Roof Panels over Classroom (Looking East)

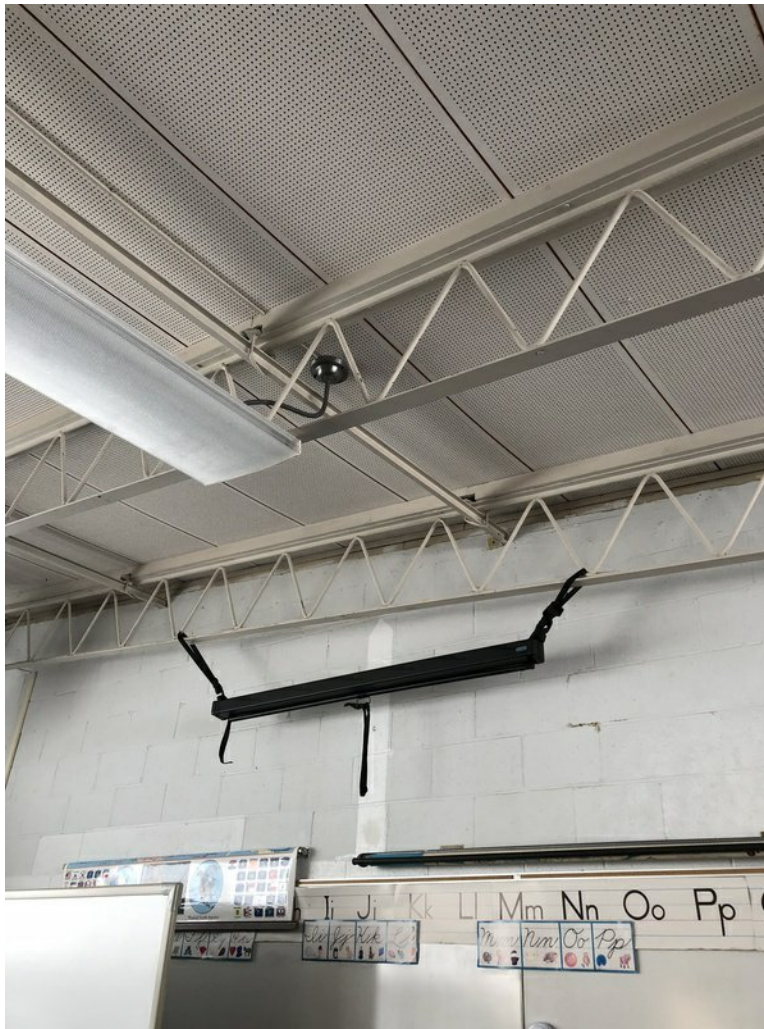
Figure 1-9. Joist Bridging Connecting to Masonry Walls
